**TRANSPORTATION SCIENCES CENTER
ACCIDENT RESEARCH GROUP**

**CALSPAN ON-SITE AIR BAG DEPLOYMENT INVESTIGATION
CALSPAN CASE NO. 95-21
VEHICLE: 1995 DODGE CARAVAN
LOCATION: MARYLAND
CRASH DATE: [REDACTED] 1995**

This on-site investigation focused on a child fatality that resulted from the deployment of the passenger side air bag in a 1995 Dodge Caravan. The 7 year old female child occupant was the right front passenger in the Caravan that was occupied by the 43 year old male driver and two additional child occupants seated in the second seat of the seven passenger vehicle configuration. On an approach to a four-leg intersection, the driver was momentarily distracted and failed to detect a red signal phase. He braked, however, the full frontal area of the Caravan impacted the left side area of a 1992 Chevrolet Lumina APV which resulted in deployment of the Dodge's supplemental driver and passenger side air bags. The right front child occupant was out of position in a forward direction as a result of the pre-crash braking force and within a close proximity to the passenger side air bag module assembly. The deploying air bag contacted the underside of her chin, face, anterior neck, an

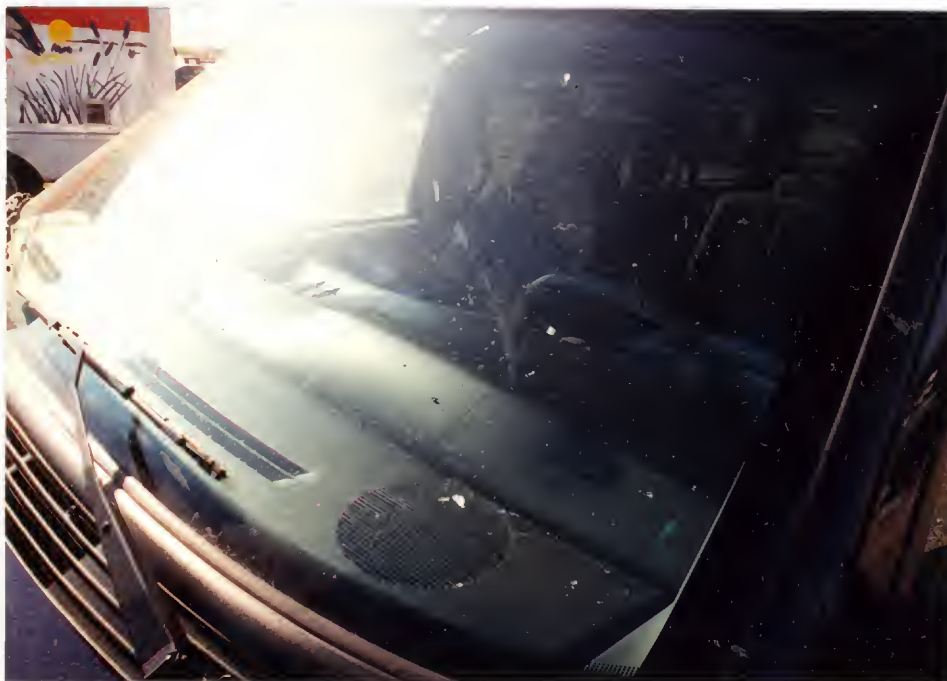
65. Exterior view of the mirror scuff across the left side of the windshield.

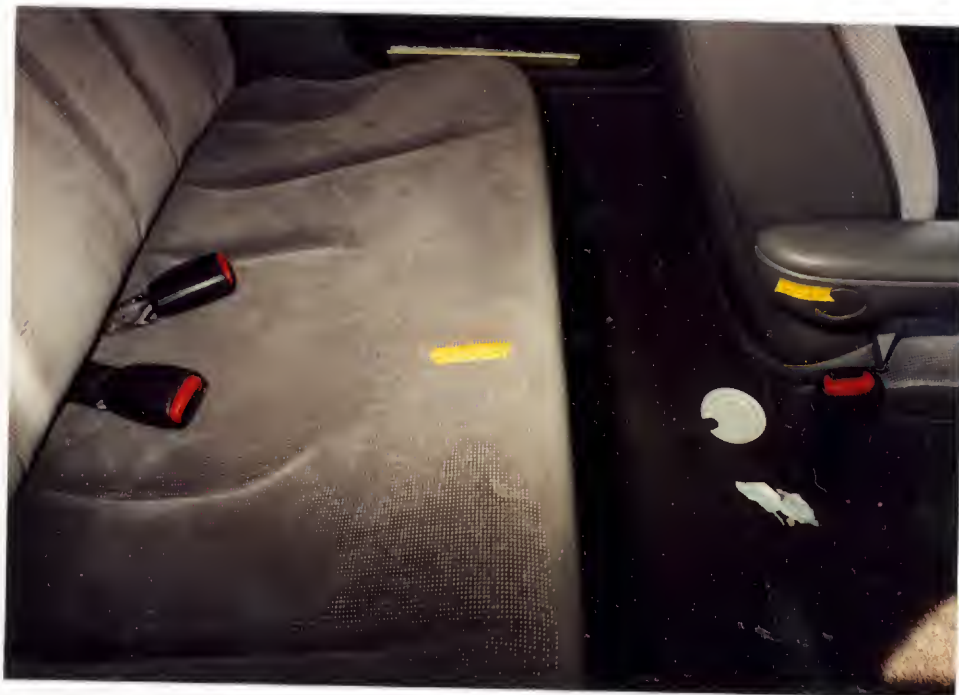
67. Blood transfer of the right (inboard) armrest of the driver's seat.

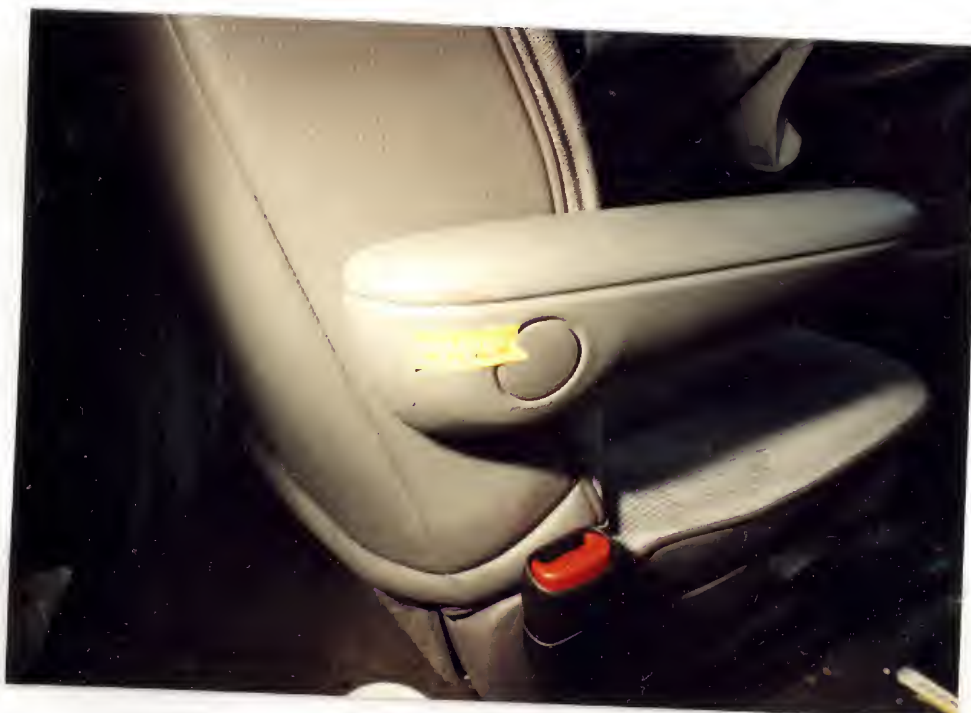
68. Close-up view of the blood transfer from final rest of the right front passenger's head/neck.

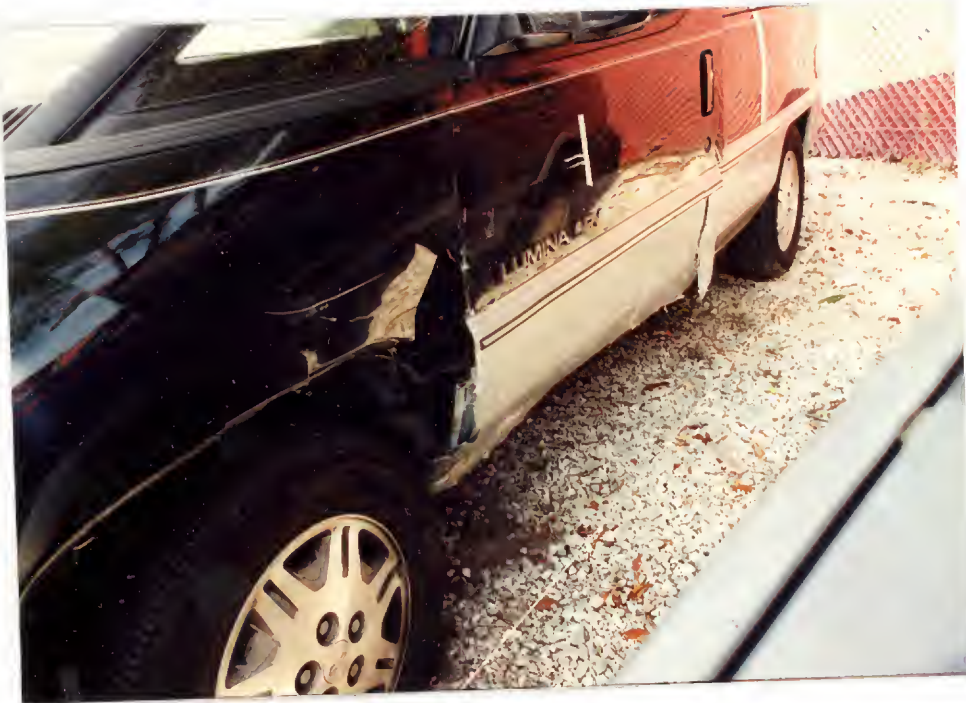
76. Direct contact damage on the left side area of the Lumina APV.

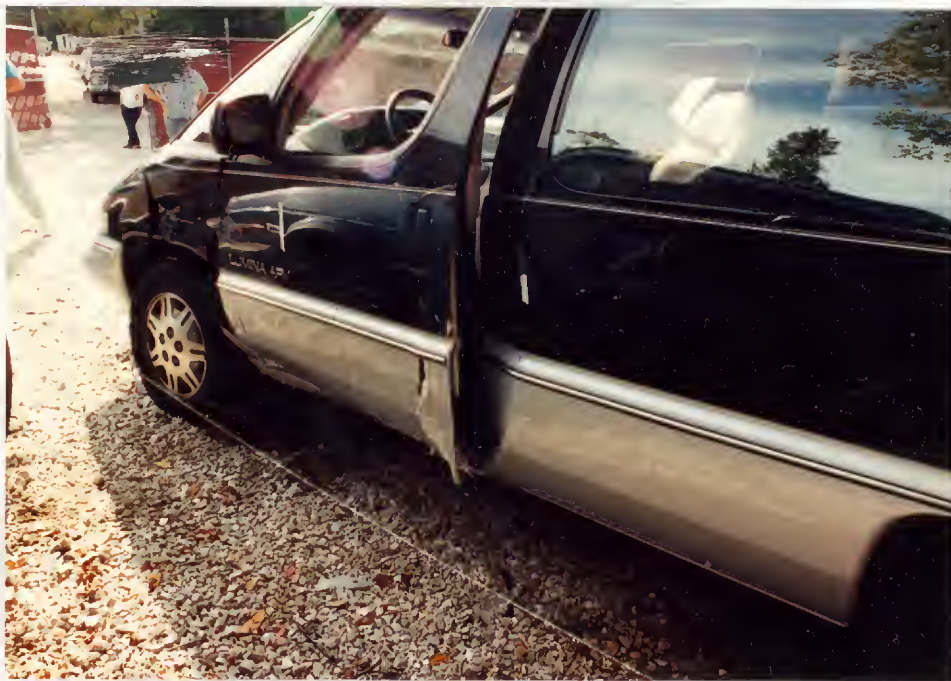
78. Close-up view of the direct contact damage.

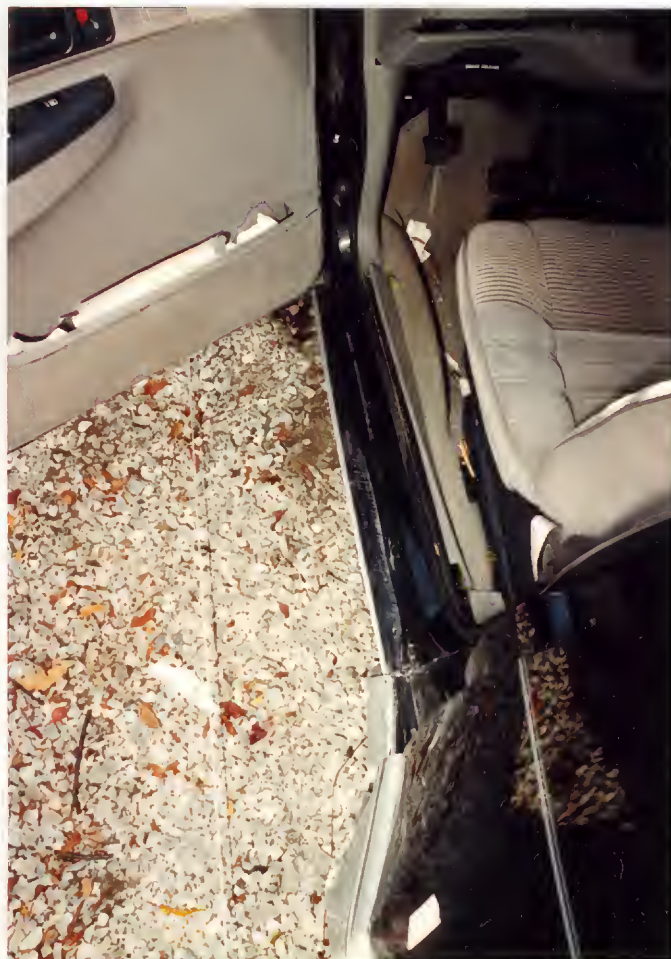
79. Lateral displacement of the left sill of the Lumina.
